A FIELD STUDY ON PHOTOLUMINESCENT SIGNAGE USED TO GUIDE BUILDING OCCUPANTS TO EXIT IN COMPLETE DARKNESS

Guyène Proulx, Ph.D., National Research Council of Canada, Ottawa, Canada

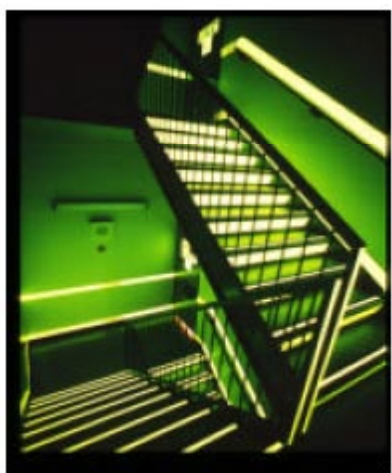
To reduce the lighting, 2 out of 3 double-tube luminaires were switched off, providing Stairwell A with an average lighting of 57 lux and Stairwell D with a slightly higher average output of 74 lux. Also, Stairwell D had PLM signs and a way guidance system installed. Stairwell C also had PLM signs and a way guidance system and had all lights switched off a few minutes before the evacuation, as presented in Figure 1.

The building's four identical stairwells were set up with different conditions, as shown in Table 1. It is important to mention that, in this building, the stairwells' emergency lighting was the full lighting with an average output of 245 lux.

For the study, the lighting conditions in three of the stairwells were modified while Stairwell B received no treatment; it acted as the control stairwell.

Lighting in Stairwells A and D was modified to obtain a reduced output of not less than 3.3 lux, which is a code requirement.
